Failure Under Pressure

By AD2 R. Vasquez-Martinez

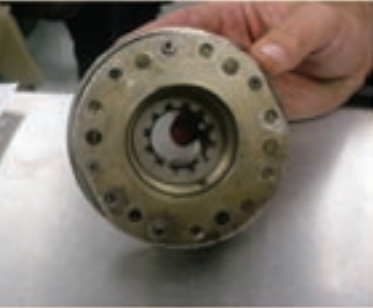
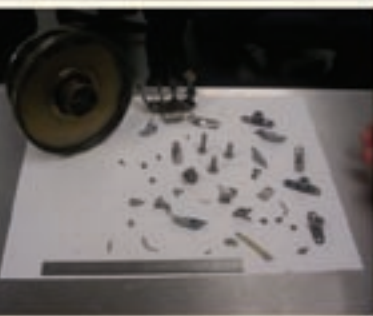
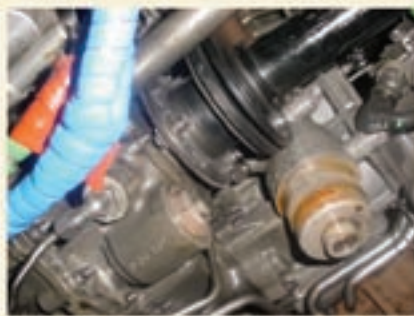
A PTS shaft separating at high speed can cause significant damage. These parts show some of the effects.

On the following Monday night, I heard about a problem with aircraft 311. A supervisor told me the power transmission shaft had sheared and parts were blown through door 64. Additionally, the gears on the accessory-gear drive were sheared, and the airframe-mounted accessory drive was damaged.

A thorough investigation found the PTS bolts never were torqued properly. A clear breakdown in communication among the workcenter, maintenance, and QA had occurred. This incident did damage the aircraft, but it could have been tragic.
